Improvement of the transmission and sub-transmission overhead lines lightning performance using line arresters – Experience in Brazil

Jorge Luiz De Franco – Franco Engenharia / Tyco Electronics - Brasil

José Pissolato Filho – Universidade Estadual de Campinas - Brazil

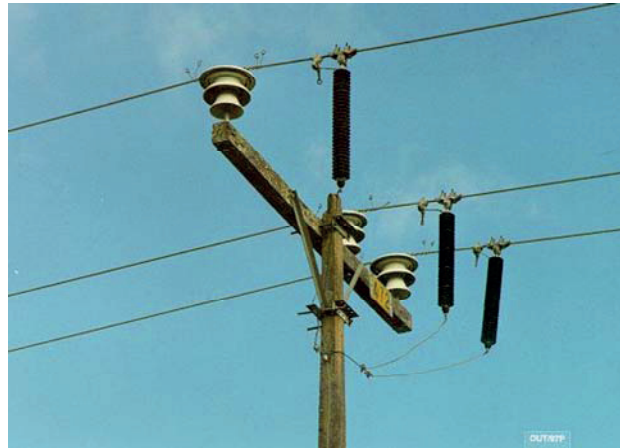
Figure 2 – Line arresters installed on 34.5 kV line – CEMIG [1]

Approximately 70% of all the gapless line arresters installed in Brazil are in the area under concession of CEMIG, located at Minas Gerais State. Besides CEMIG, FURNAS, Ampla, Light, CFLCL, UTEJF, Escelsa, RGE, CEEE, Porto Primavera Transmissora de Energia – PPTE and one industrial consumer - CVRD have been already installed or acquired line arresters to install along their 34.5 kV to 220 kV overhead lines. Details of the line arresters installed are shown in Figures 2 to 4.

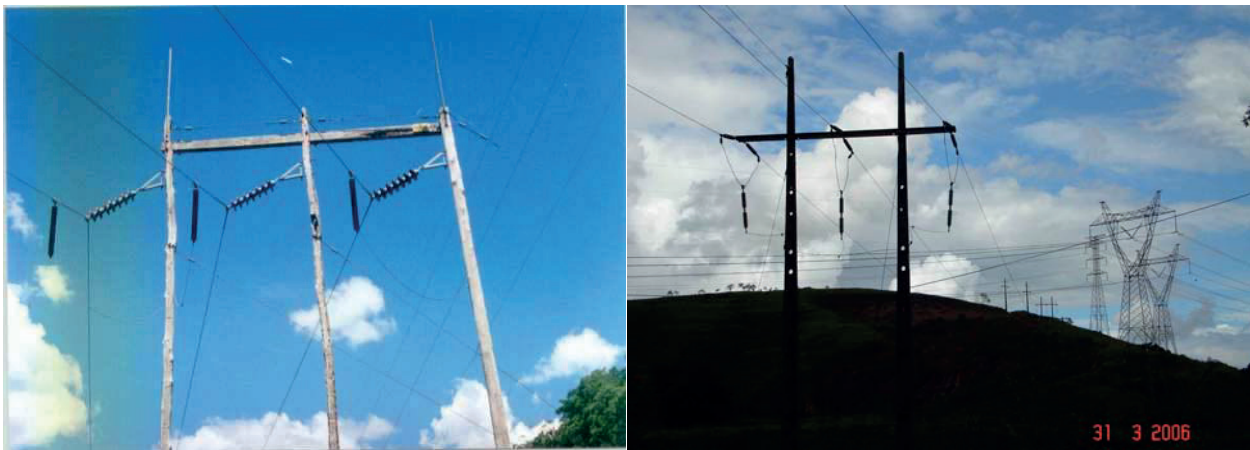
Figure 3 – Line arresters installed on 69 kV lines: Left CEMIG / Right Ampla

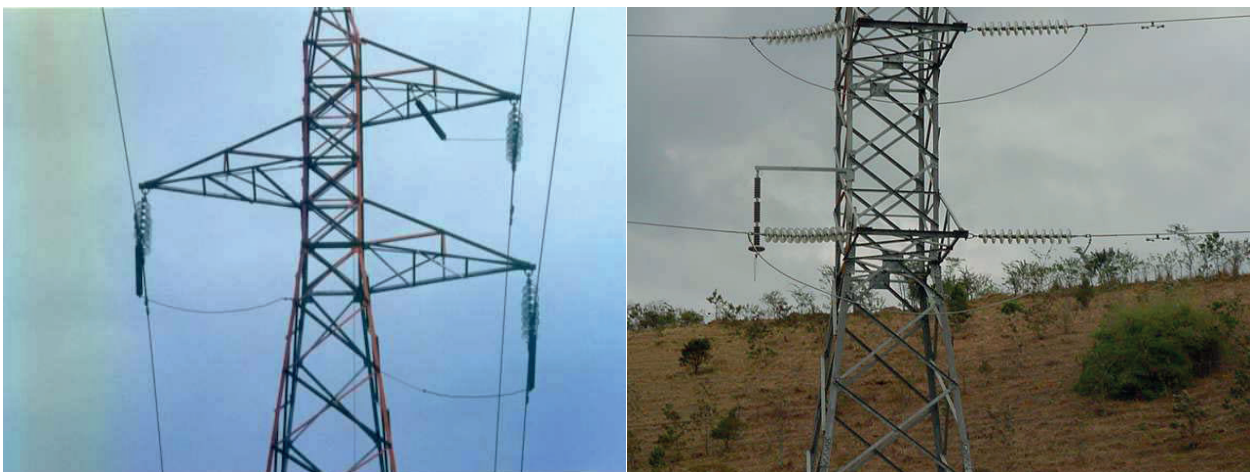
Figure 4 – Line arresters installed on 138 kV lines: Left – CEMIG / Right - UTEJF
